Custa Rail Trail Planning Study & Economic Impact Analysis

March 2012

Rail Line Structural Assessment

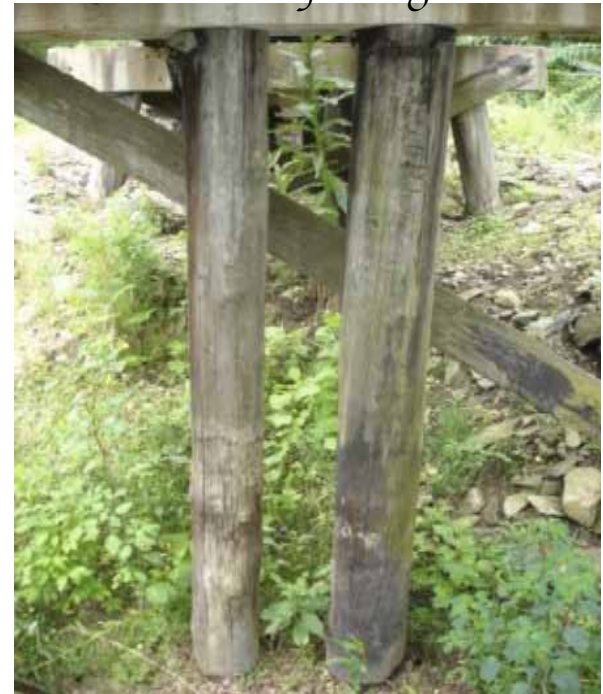
Substructure: – Both back walls are in poor condition with signs of decay, deterioration, and severe weathering. There is minor undermining and detaching of wing walls. Timber caps are in satisfactory condition with top 1/2" deteriorated. Timber piles show no signs of deterioration and only minor weathering, but do show signs

of deflecting. Metal sheathing shows signs of oxidation, resulting in severe corrosion. Wood shims show signs of severe deterioration. Substructure shows no signs of debris collection or vegetation growth. Sway braces show signs of minimal weathering and deterioration. Stone pile supports of river span show no signs of deflection or erosion. Metal bridge span shows surface rust, but no severe corrosion present.

Timber Piles Deflecting

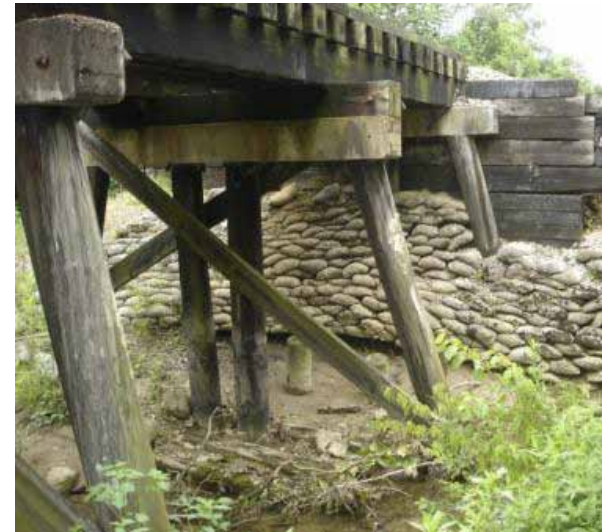
Substructure – Both back walls are in satisfactory condition, with minimal signs of deterioration and weathering. There is minor undermining and detachment of walls. North back wall constructed of concrete bags and timber ties.

North Back Wall

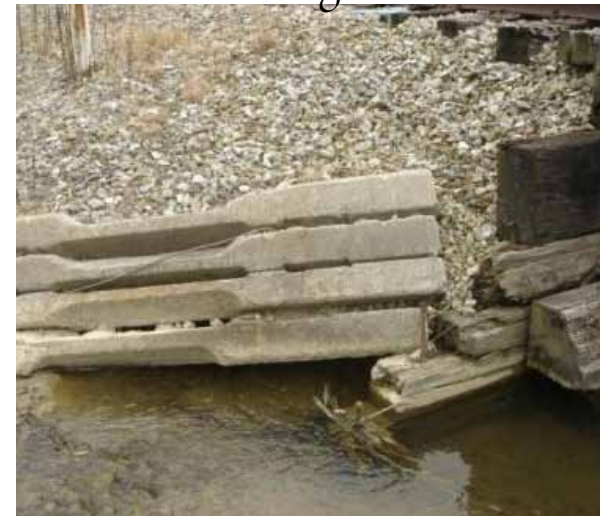
Concrete Tie Wing Wall

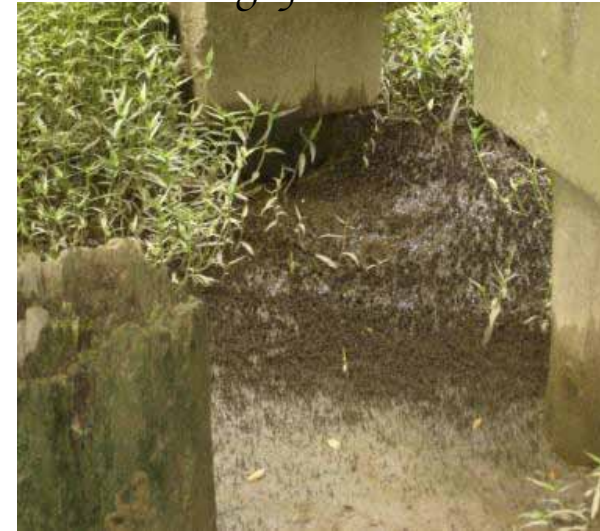
Substructure – Both back walls are in poor condition with signs of deterioration and weathering. Both back walls are further supported by stacked concrete ties. Minor undermining and detachment of walls are occurring as a result of frequent flooding. Back walls constructed of timber ties. Timber piles show signs of deterioration and weathering due to frequent flooding. Wood shims show signs of minor deterioration. Substructure shows signs of debris collection and significant vegetative growth.

Undermining of Timber Piles

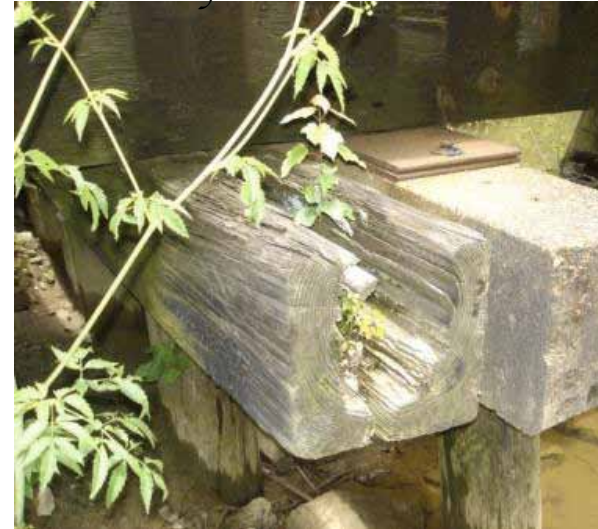
Substructure – Both back walls are in poor condition, with signs of deterioration and weathering. There is severe undermining and detachment of timber tie back walls. Timber piles show signs of deterioration and weathering due to frequent flooding. Wood shims show signs of minor deterioration. Substructure shows signs of debris collection and significant vegetative growth.

Timber Cap Deterioration

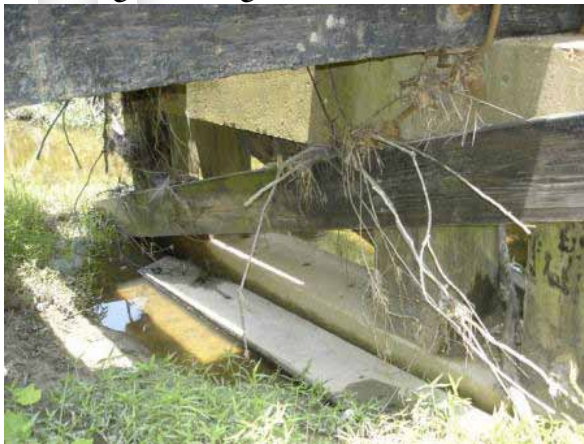
Substructure – Both back walls are in poor condition, with signs of decay, deterioration and severe weathering. There is minor undermining and detaching of walls. Timber piles show signs of deterioration and minor weathering due to frequent flooding; Timber piles' foundations are underwater (unknown depth). Wood shims

show signs of severe deterioration. Substructure shows significant signs of debris collection and vegetative growth due to frequent flooding.

Debris and Visual Foundation During Drought

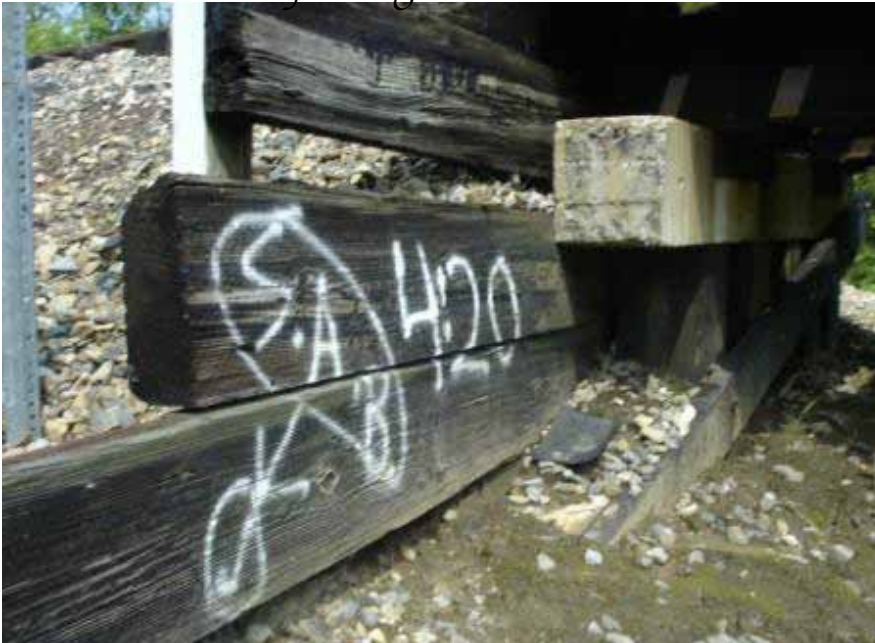
Substructure – Both back walls are in poor condition, with signs of decay, deterioration and severe weathering. There is minor undermining and detaching of wing walls. Timber caps are in satisfactory condition, with top 1/2" deteriorated. Timber piles show no signs of deterioration and only minor weathering, but do show signs

of deflecting. Metal sheathing showing signs of oxidation, resulting in severe corrosion. Wood shims show signs of severe deterioration. Substructure shows no signs of debris collection or vegetation growth. Sway braces show signs of minimal weathering and deterioration. Stone pile supports of river span show no signs of deflection and minimal erosion. Metal bridge span shows surface rust, but no severe corrosion present.

Timber Piles Deflecting

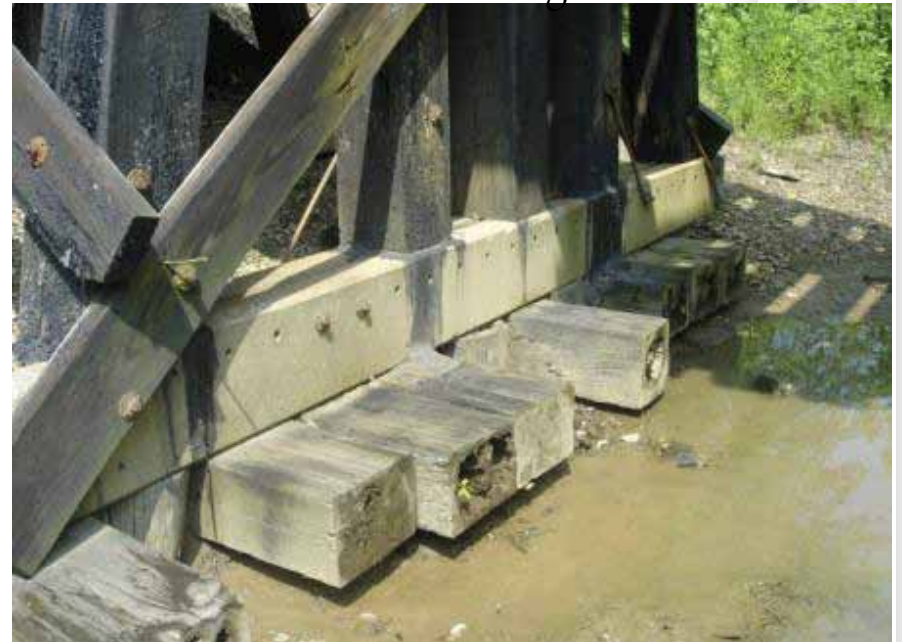
Bent Foundation Undermining

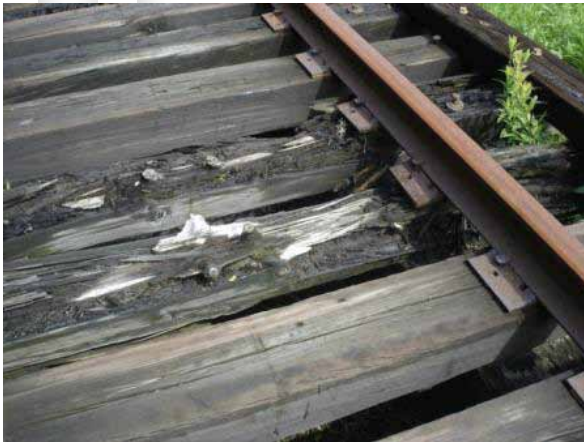
Deck and Superstructure – Ties are deteriorating and deflecting, causing shifts in overall alignment of superstructure. Girders are in satisfactory condition, with few areas of deterioration and minor weathering. Guard and running rails are deflecting, causing shift and detachment of decking.

Tie Deterioration

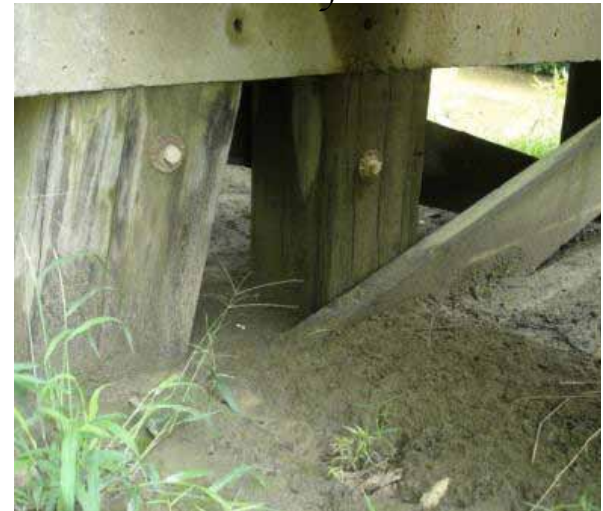
Sediment and undermining of timber piles and back walls is caused by frequent flooding.

Sediment Build-up

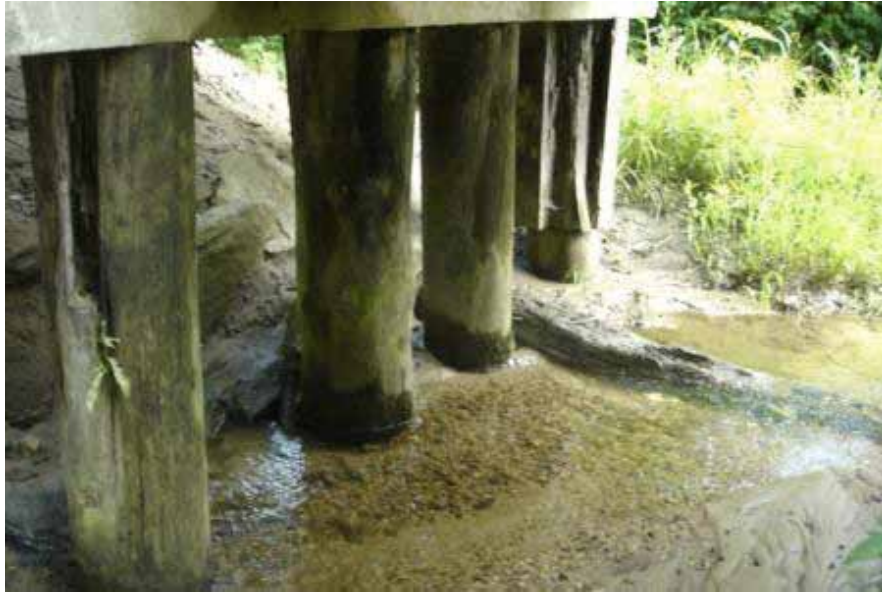
Substructure – Both back walls are in poor condition, with significant signs of decay, deterioration and weathering. There is severe undermining of both north and south back walls and wing walls. Timber piles show significant signs of deterioration and hollowing. Concrete caps are in satisfactory condition, with no signs of cracking. Wood shims show minor signs of deterioration. Substructure shows no signs of debris collection but does show wetland vegetative growth.

Timber Pile Deterioration

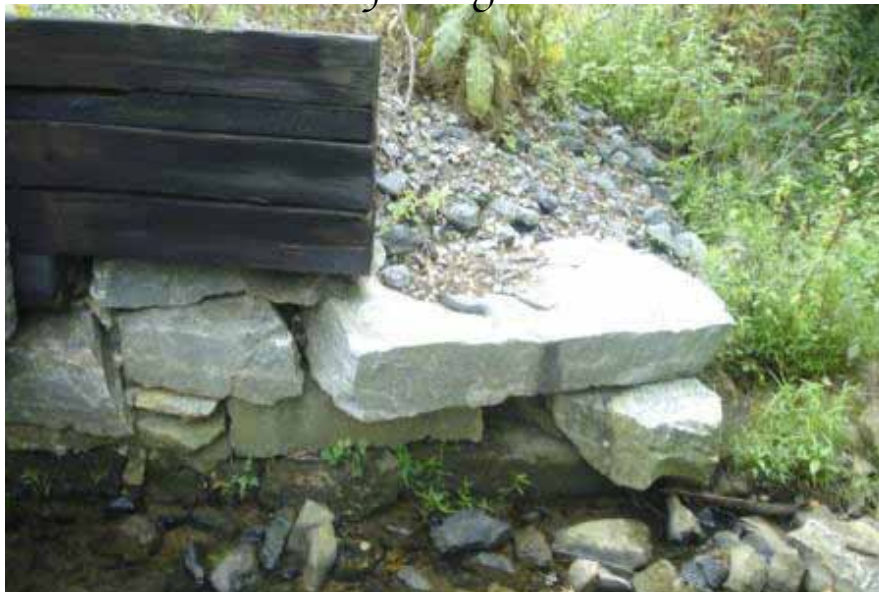
Substructure – Both back walls are in poor condition, with significant signs of decay, deterioration and weathering. There is severe undermining and deflection of both north and south back walls and wing walls. Sediment and undermining of stone foundation and back walls is caused by frequent flooding.

North Back Wall Deflecting

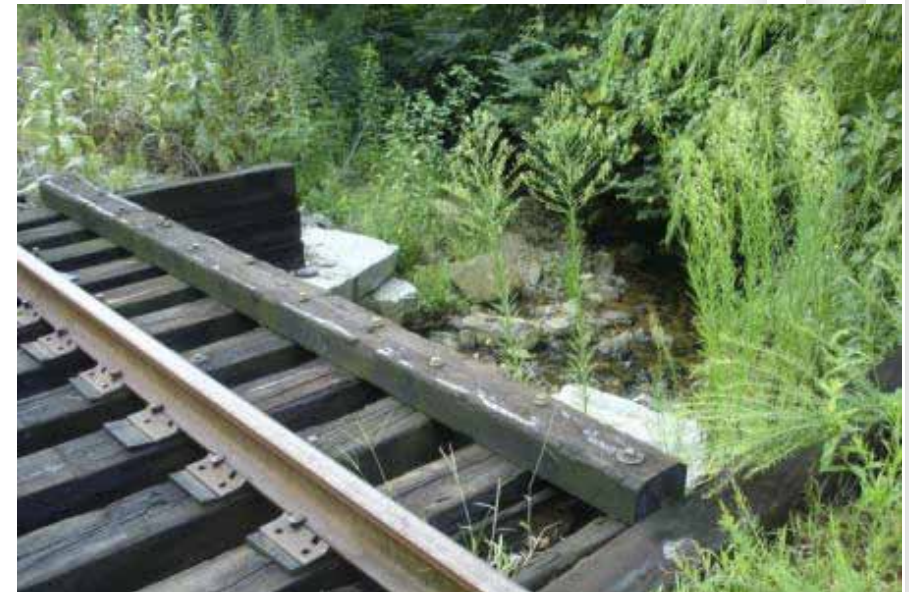
Deck and Superstructure – Ties are deteriorating and deflecting, causing shifts in overall alignment of superstructure. Girders are in satisfactory condition, with few areas of deterioration and minor weathering. Guard and running rails are deflecting, causing shift and detachment of decking and are in poor condition.

Tie and Timber Deterioration

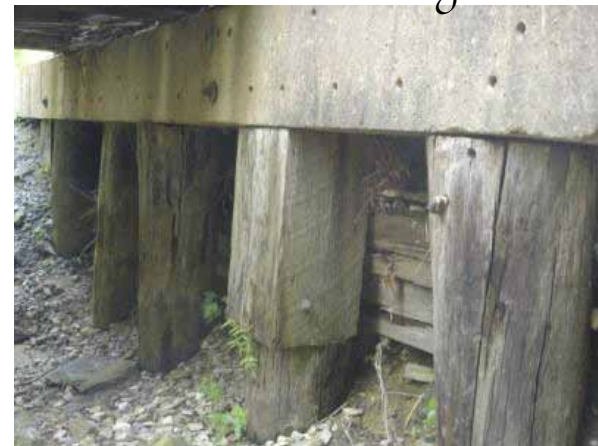
Block Wall Undermining

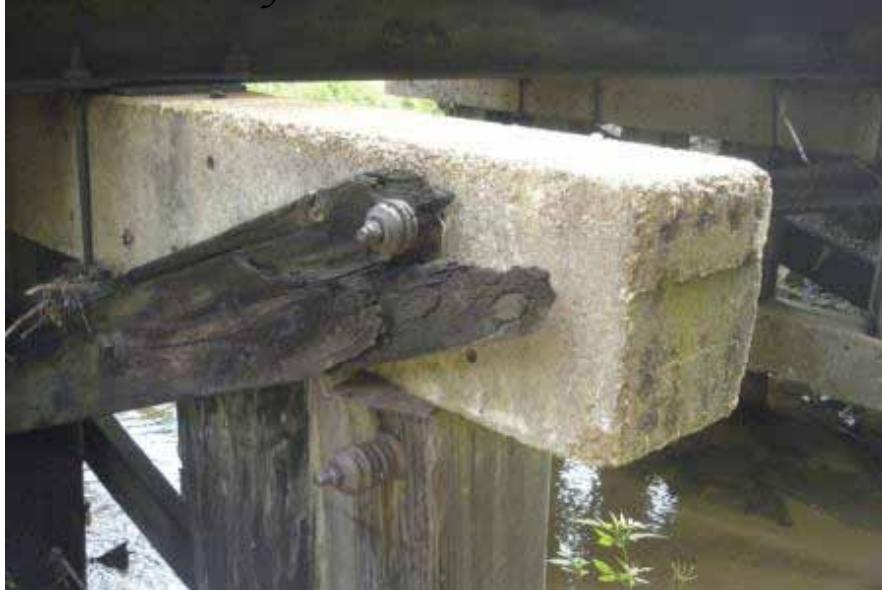
Deterioration of Timber Cross Brace

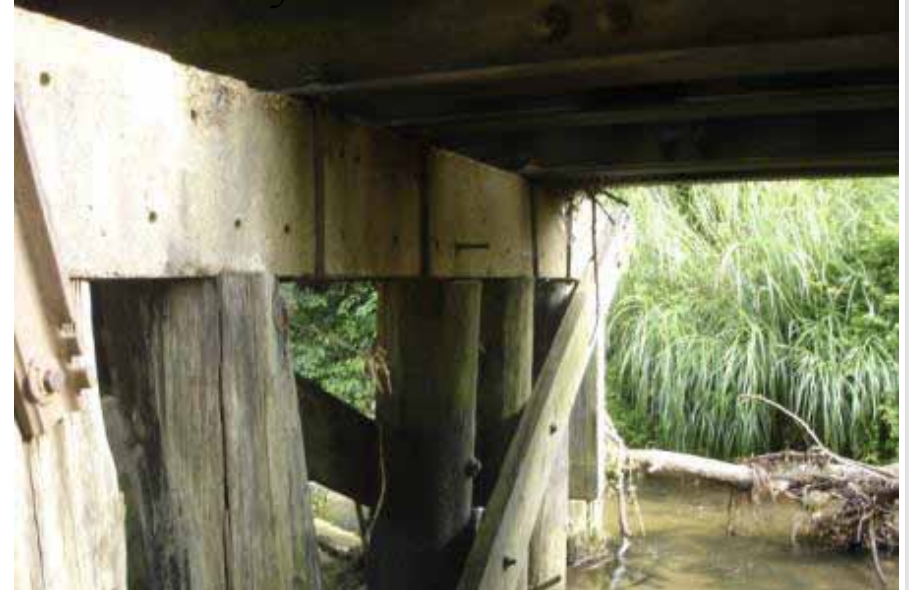
Substructure – Both back walls are in fair condition, with minor signs of deterioration and weathering. There is minor undermining and detaching of walls. Timber piles show signs of deterioration and minor weathering due to frequent flooding; Some timber piles and foundations of bents are underwater (unknown depth).

Deterioration of Timber Piles

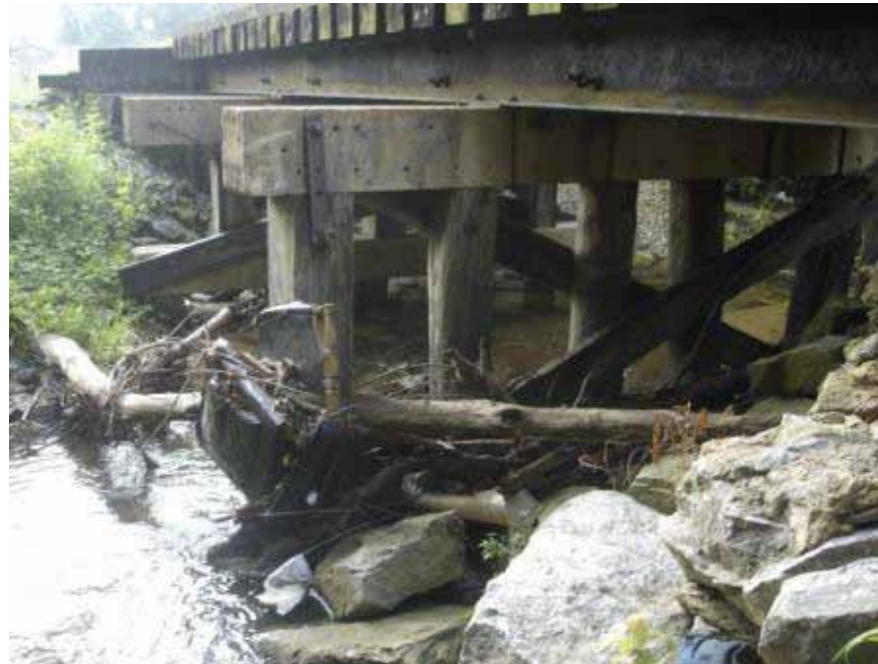
Wood shims show signs of severe deterioration. Substructure shows significant signs of debris collection and vegetative growth due to frequent flooding.

Debris Collection

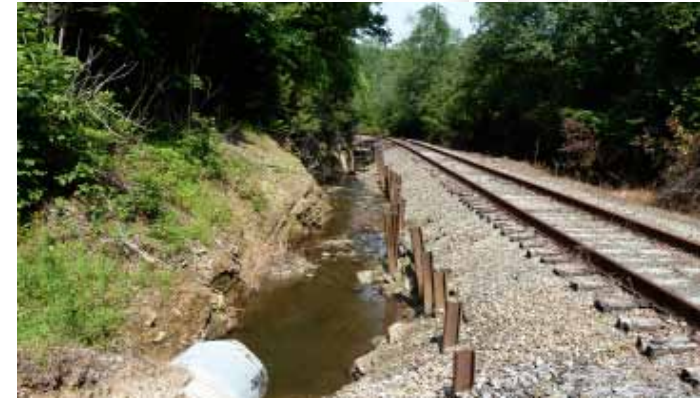
There are some areas with erosion or other environmental degradation along the rail line that may require remediation.
