Custa Rail Trail Planning Study & Economic Impact Analysis

March 2012

Rail Line Structural Assessment

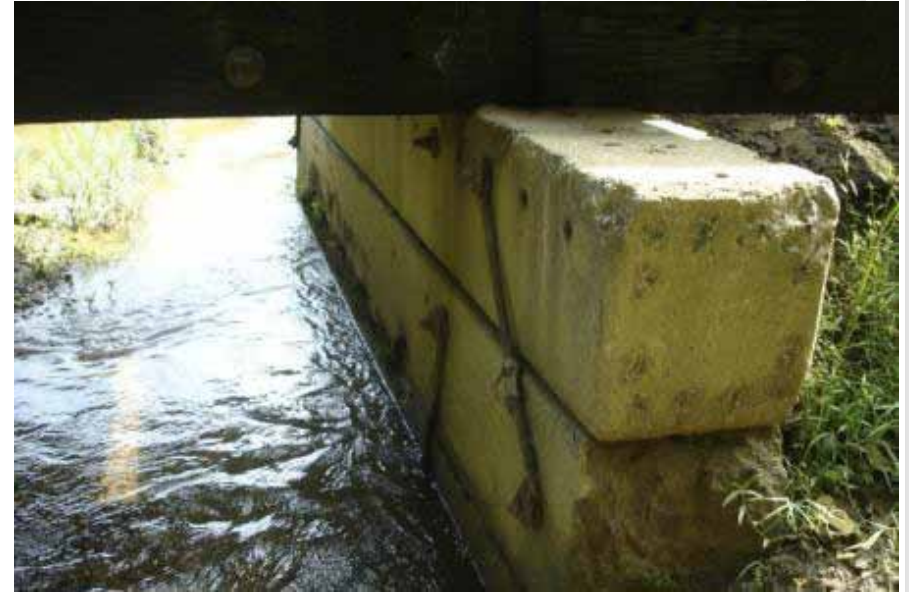
Substructure – Both back walls are in satisfactory condition, with minor signs of decay, deterioration and weathering. There is minor undermining of wing walls. Concrete caps are in satisfactory condition, with no signs of cracking. Wood shims show minor signs of deterioration. Substructure shows no signs of debris collection, but does show wetland vegetative growth. Sediment and undermining is caused by frequent flooding.

South Back Wall

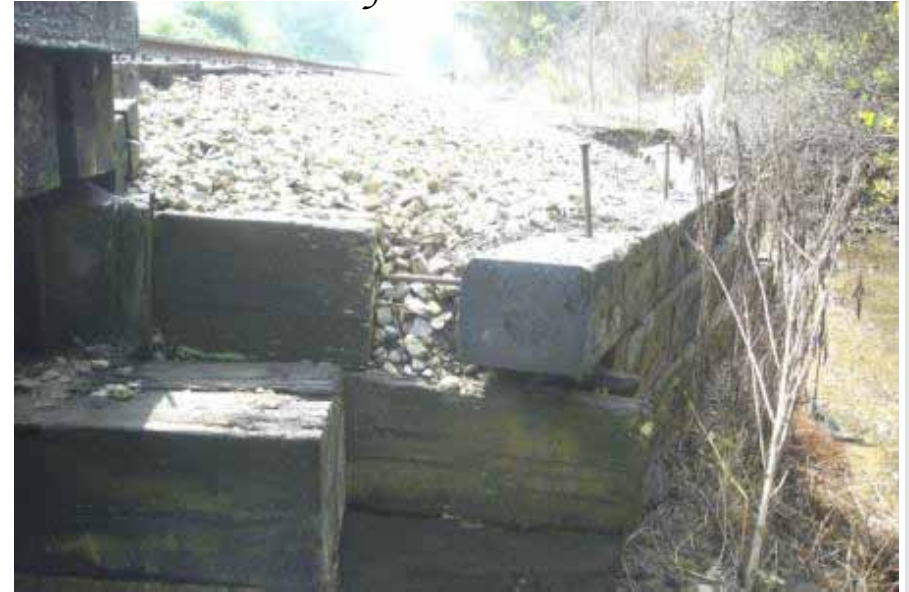
Substructure – Both back walls are in poor condition, with significant signs of decay, deterioration and weathering. There is severe undermining of both north and south back walls and wing walls. Timber piles show significant signs of deterioration and hollowing. Concrete caps are in satisfactory condition, with no signs of cracking. Wood shims show minor signs of deterioration. Substructure shows no signs of debris collection but does show wetland vegetative growth.

South Back Wall Deflection
