Custa Rail Trail Planning Study & Economic Impact Analysis

March 2012

Rail Line Structural Assessment

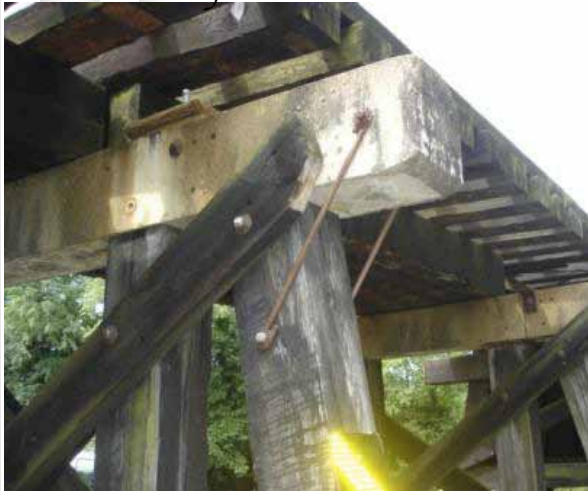
Concrete Caps

Deck and Superstructure – Ties are deteriorating and causing debris to accumulate along the girders and metal sheathing. Ties are also deflecting, causing shift in the overall alignment of the superstructure. Girders are in satisfactory condition with few areas of deterioration and minor weathering. Guard and running rails are deflecting, causing shift and detachment of the decking.

Substructure: – Both back walls are in poor condition with signs of decay, deterioration, and severe weathering. There is minor undermining and detaching of wing walls. Timber caps are in satisfactory condition with top 1/2" deteriorated. Timber piles show no signs of deterioration and only minor weathering, but do show signs

of deflecting. Metal sheathing shows signs of oxidation, resulting in severe corrosion. Wood shims show signs of severe deterioration. Substructure shows no signs of debris collection or vegetation growth. Sway braces show signs of minimal weathering and deterioration. Stone pile supports of river span show no signs of deflection or erosion. Metal bridge span shows surface rust, but no severe corrosion present.

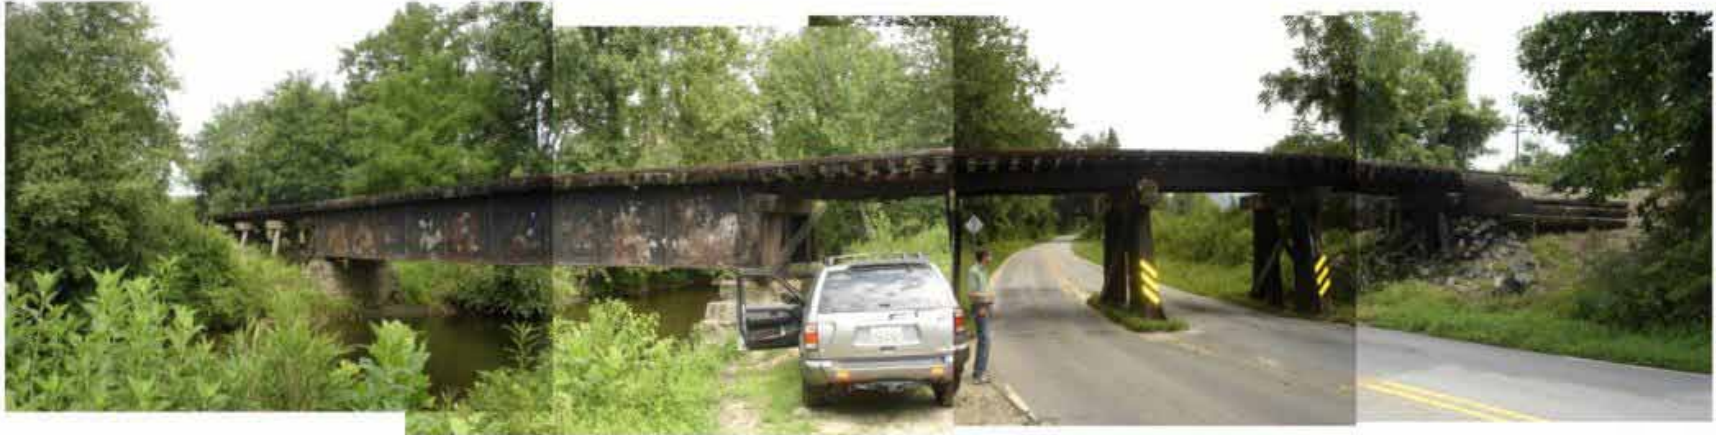
Panoramic

Deck and Superstructure – All ties are severely deteriorating along the girders. Ties are also deflecting, causing shift in overall alignment of superstructure. Girders are in satisfactory condition, with few areas of deterioration and minor weathering. Guard rails are severely deteriorated.

Substructure – Both back walls are in poor condition with signs of decay, deterioration and severe weathering. There is minor undermining and detaching walls. Timber piles show no signs of deterioration and only minor weathering; however, most of the piles are underwater (unknown depth). Wood shims show signs of severe deterioration. Substructure shows no signs of debris collection or vegetation growth.

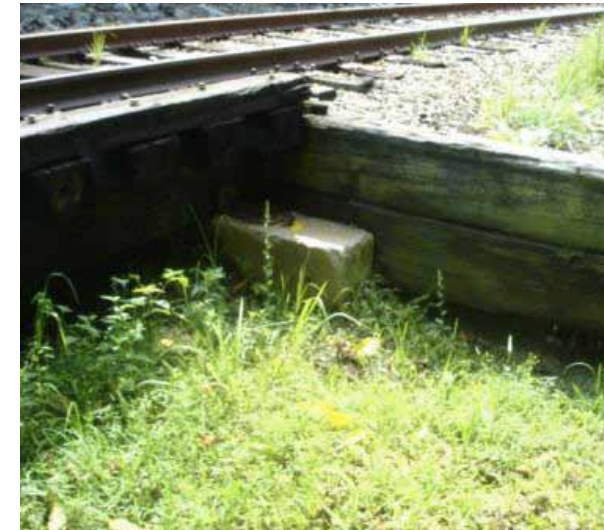
Substructure – Both back walls are in satisfactory condition, with minor signs of decay, deterioration and weathering. There is minor undermining of wing walls. Concrete caps are in satisfactory condition, with no signs of cracking. Wood shims show minor signs of deterioration. Substructure shows no signs of debris collection, but does show wetland vegetative growth. Sediment and undermining is caused by frequent flooding.

North Back Wall

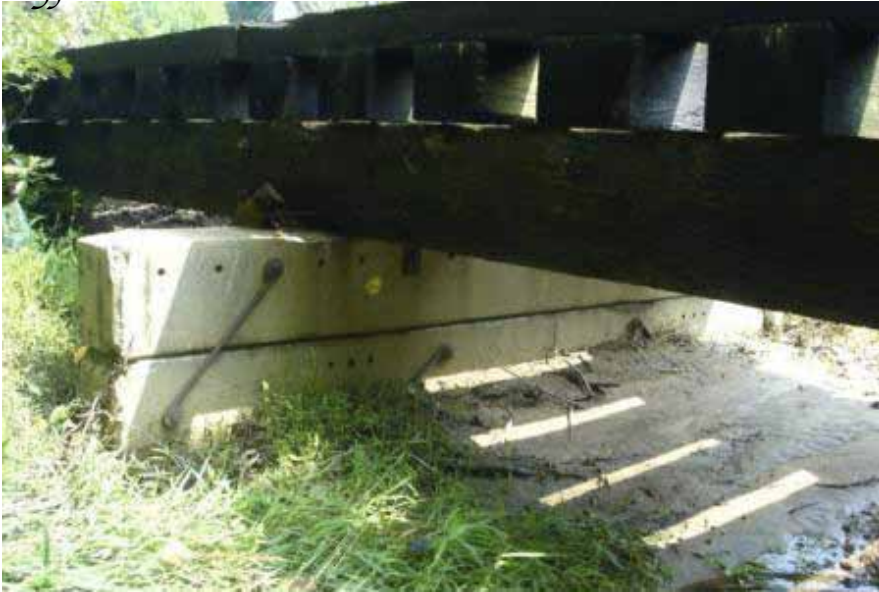
Typical Bent

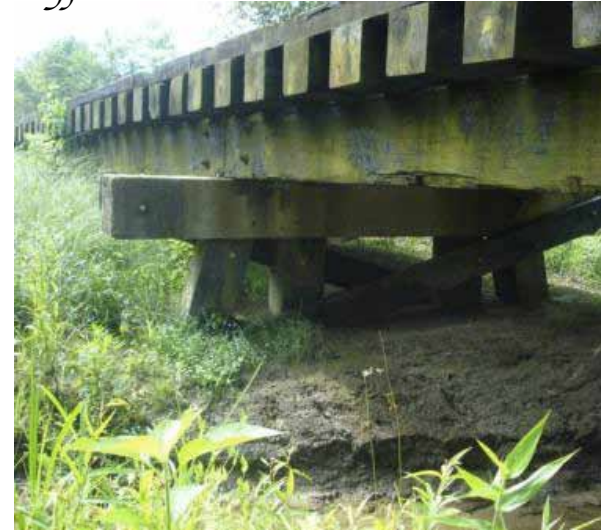
Typical Bent

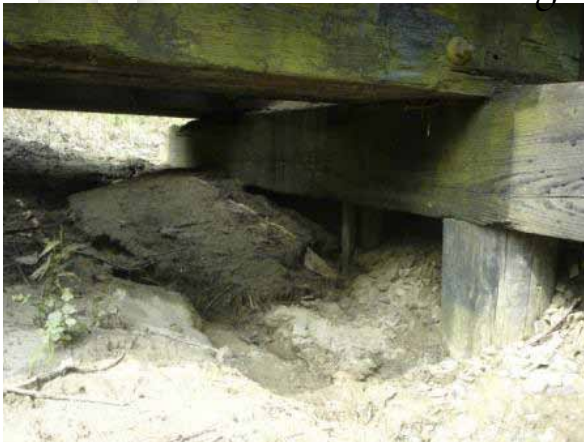
Substructure – Both back walls are in poor condition, with significant signs of decay, deterioration and weathering. There is severe undermining of both north and south back walls and wing walls. Timber piles show significant signs of deterioration and hollowing. Concrete caps are in satisfactory condition, with no signs of cracking. Wood shims show minor signs of deterioration. Substructure shows no signs of debris collection but does show wetland vegetative growth.

Sediment and undermining of timber piles and back walls is caused by frequent flooding.

North Back Wall Undermining

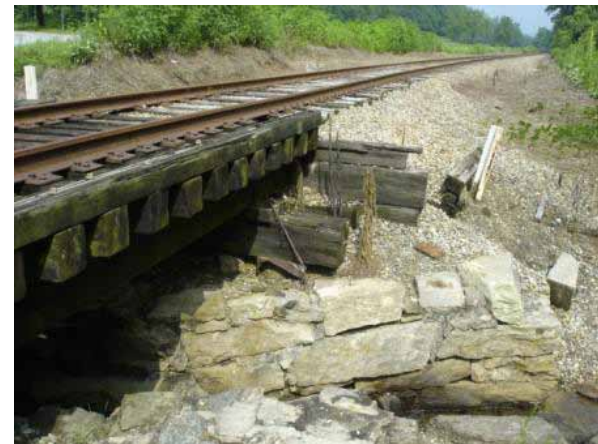
Substructure – Both back walls are in poor condition, with significant signs of decay, deterioration and weathering. There is severe undermining and deflection of both north and south back walls and wing walls. Sediment and undermining of stone foundation and back walls is caused by frequent flooding.

North Back Wall and Stone Foundation

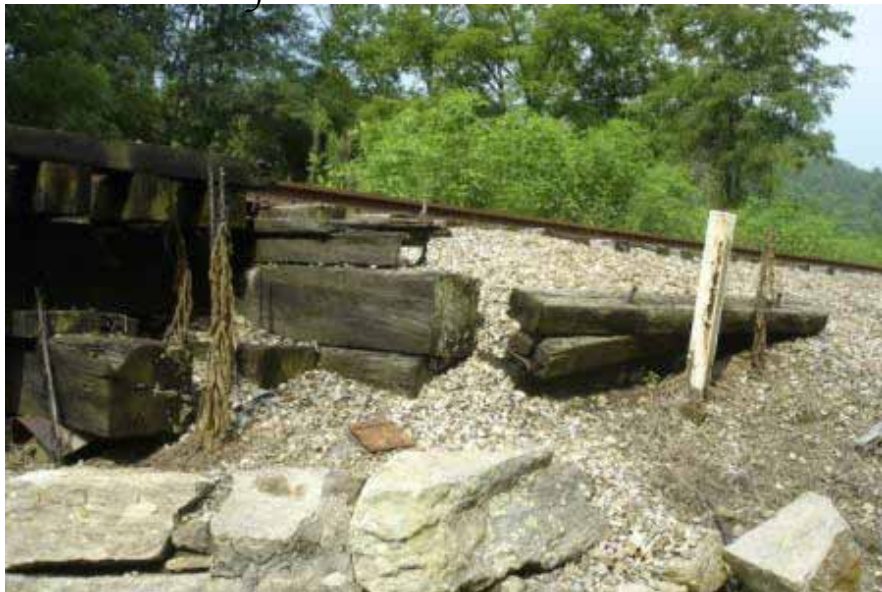
Back Wall Deflection

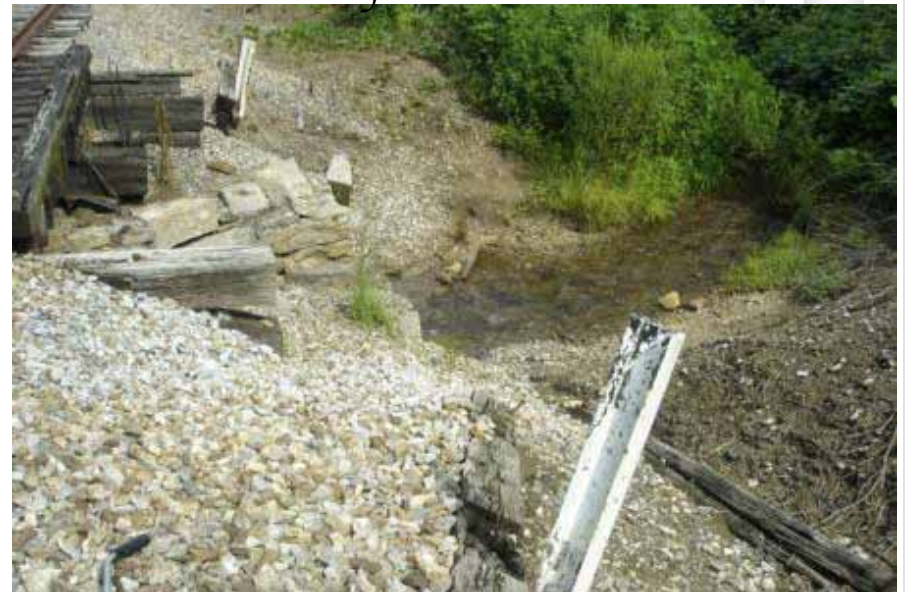
South Back Wall Deflection

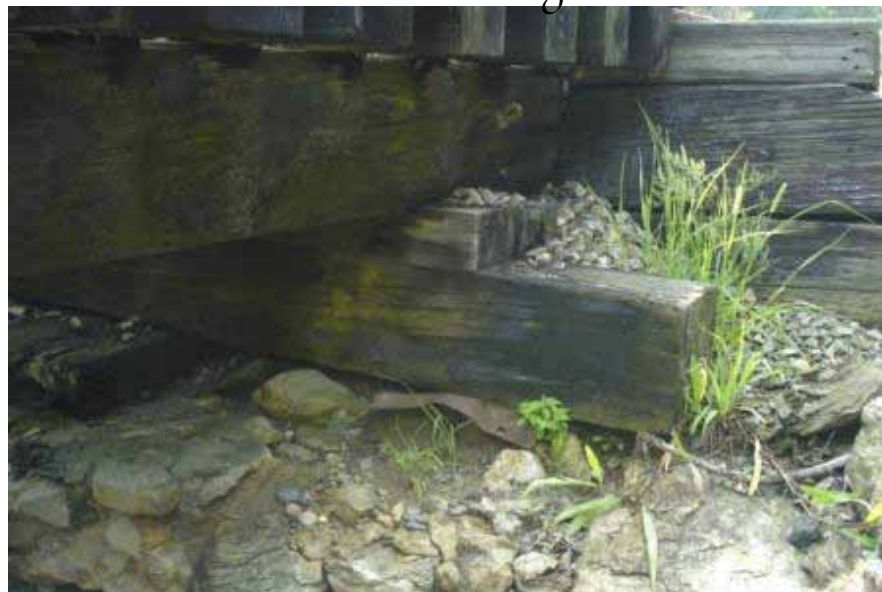
North Back Wall Undermining

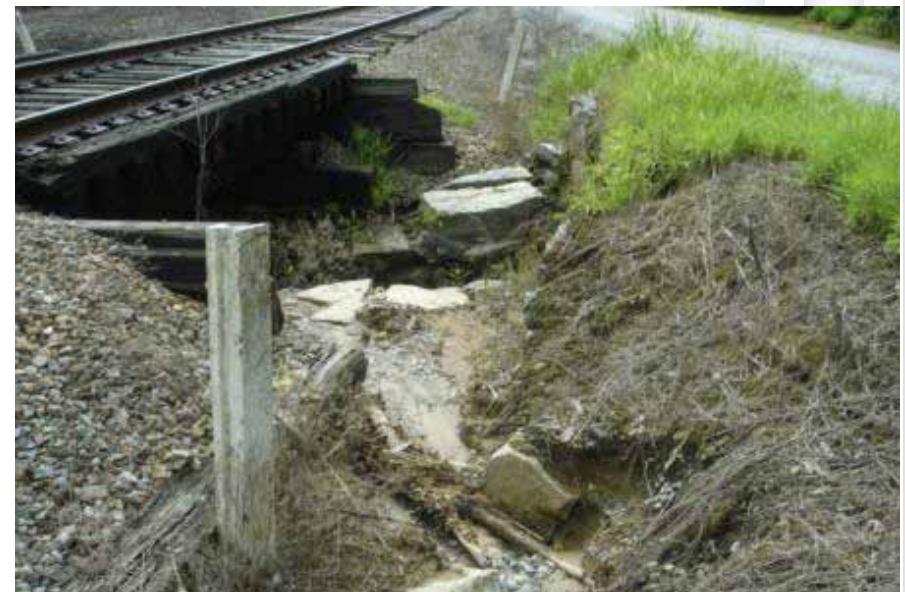
Severe Erosion

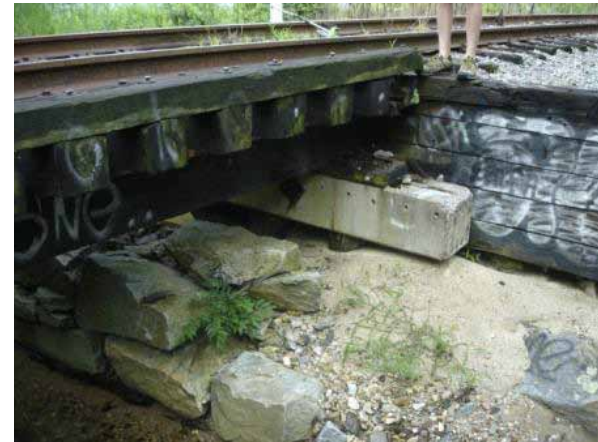
Substructure – Both back walls are in poor condition, with significant signs of decay, deterioration and weathering. There is severe undermining and deflection of both north and south back walls and wing walls. Sediment and undermining of stone foundation and back walls is caused by frequent flooding.

North Back Wall

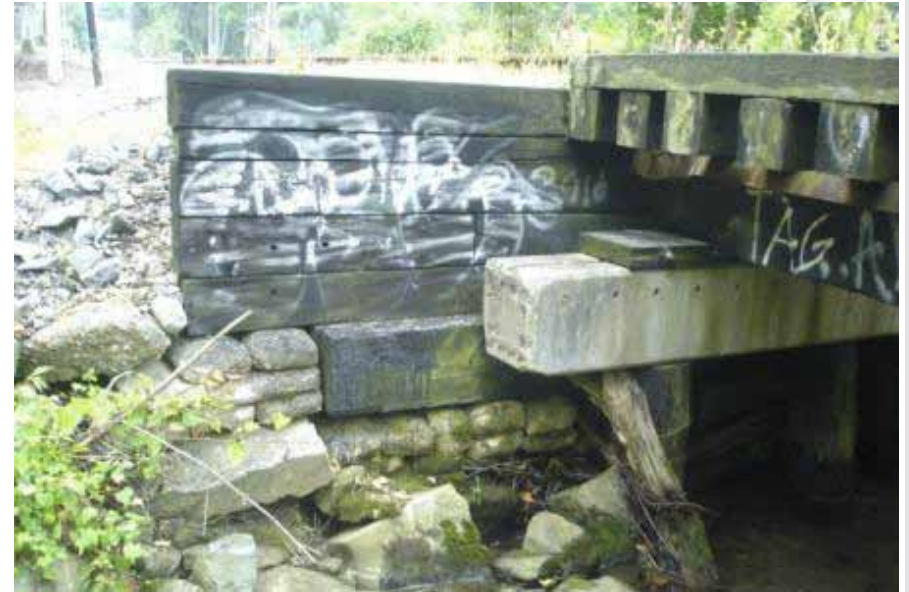
South Back Wall

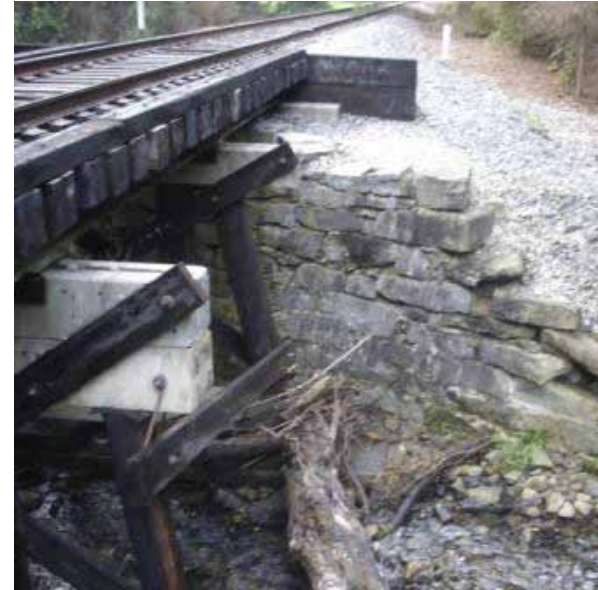
Substructure – Both back walls are in fair condition, with minor signs of deterioration and weathering. There is minor undermining and detaching of walls. Timber piles show signs of deterioration and minor weathering. Substructure shows significant signs of debris collection and vegetative growth due to frequent flooding. Stacked stone wall at edge of water shows signs of mortar cracking, undermining, and deflecting.

North Back Wall and Stone Foundation

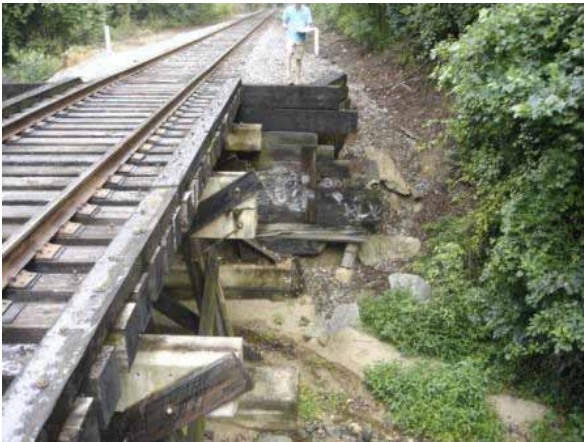
South Back Wall

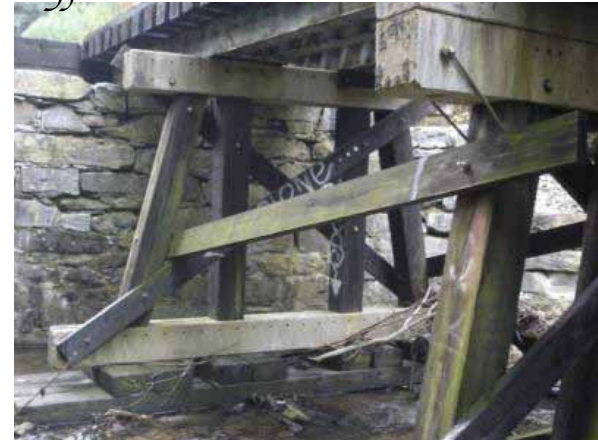
Typical Bent

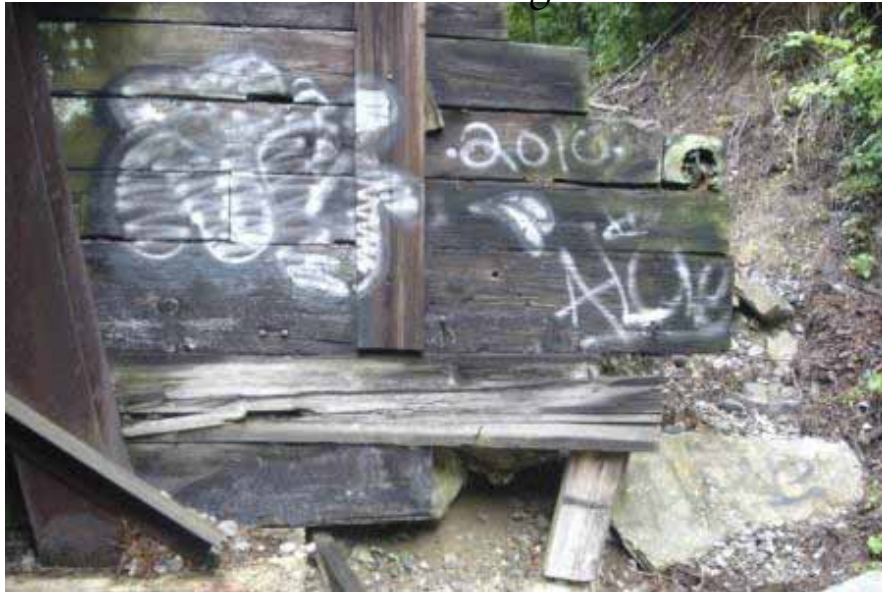
South Back Wall Undermining

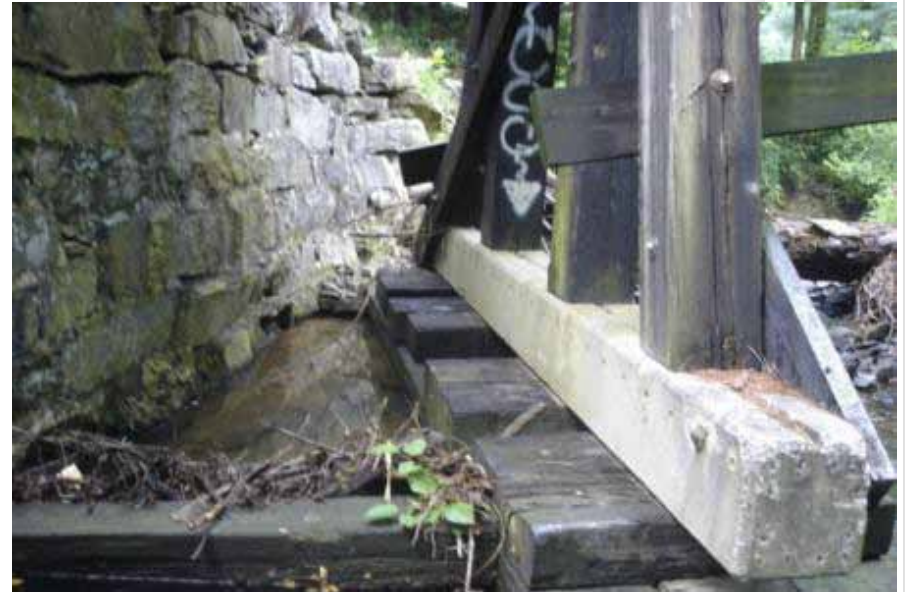
Debris Collection

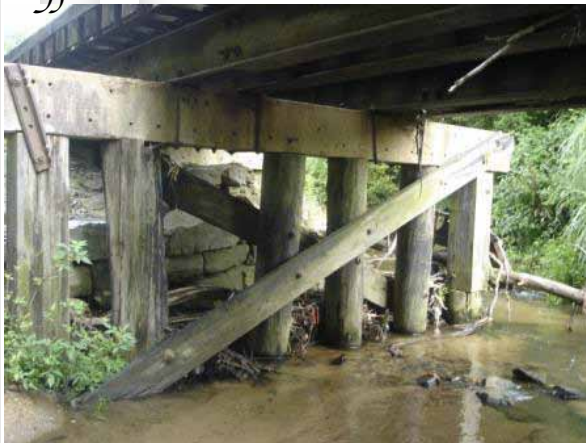
Typical Bent

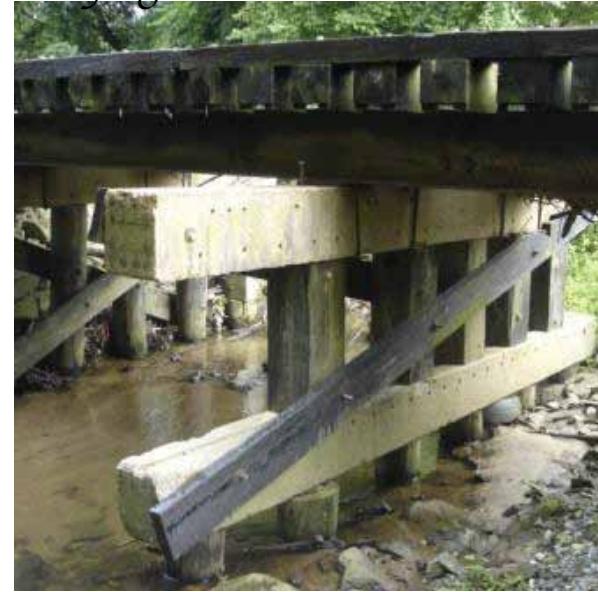
Varying Bent Sections Occur
